PROJECT NEEDS

Structural Deficiencies of the Bridge

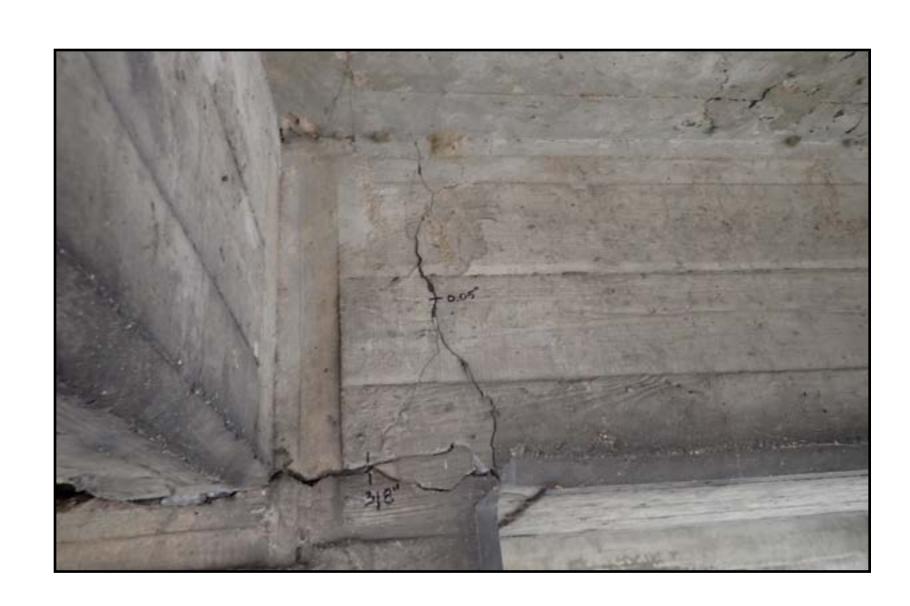
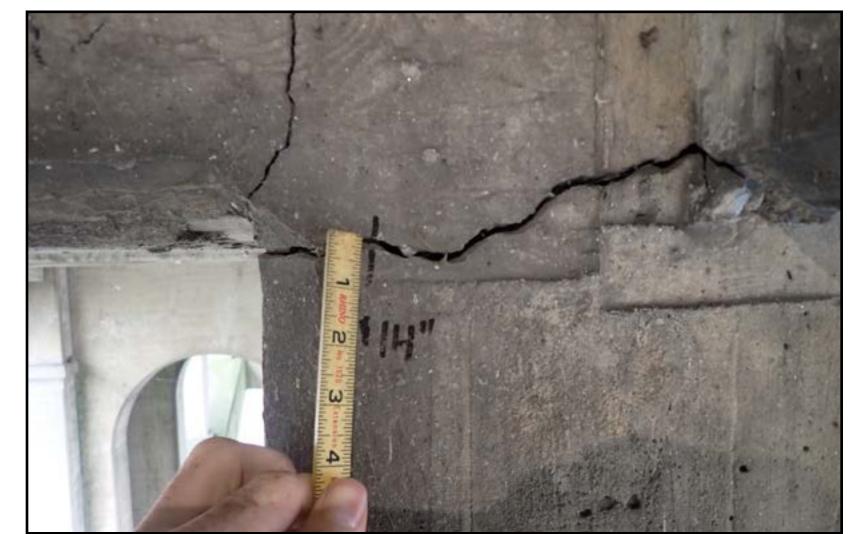
- ► The bridge deck is cracking throughout
- ► The superstructure exhibits cracking, spalling, and exposed corroded rebar
- The sidewalk has broken sections and is uneven throughout
- ► Water infiltrating cracks and joints in the bridge has caused damage or failure of various structural components
- ► The bridge barriers do not meet current crash requirements
- ► Arch span columns and beams have reduced support for the bridge deck

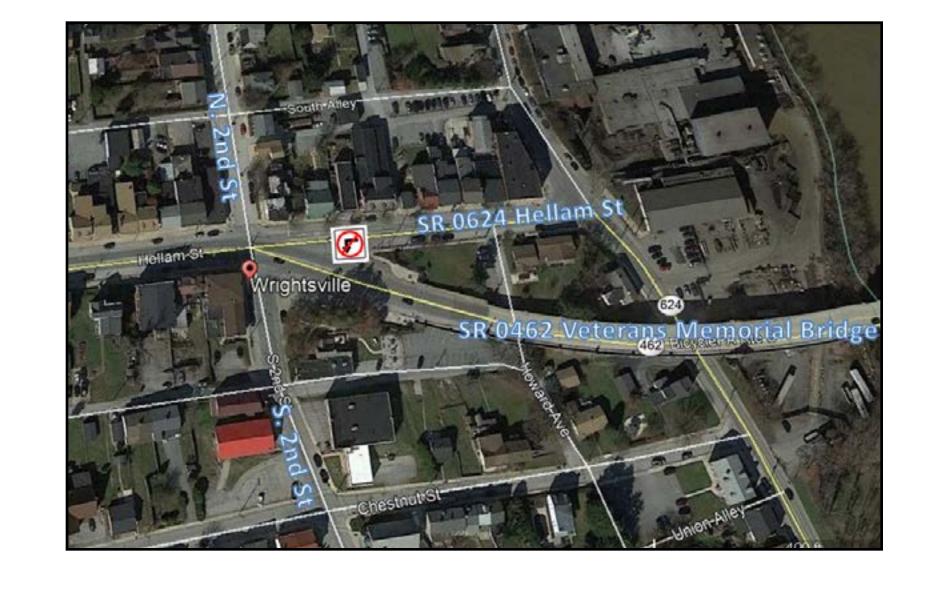
- ► Unusual 5-point intersection
- ► Bicycle and pedestrian movements at the intersection are substandard (excessive length, lack of markings, no traffic control devices)
- Select turning movements at the intersection are prohibited
- ► Sight distances for various user modes is limited

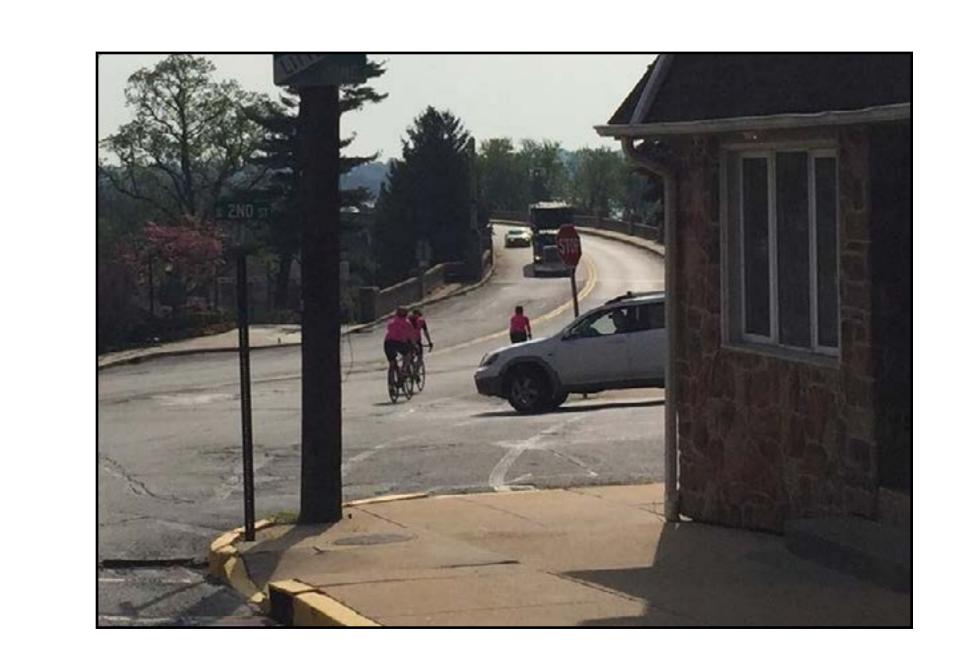
- ► Currently no bike lanes exist to delineate and limit interactions between cyclists and non-cyclists
- ► There is lack of adequate markings and signage directing pedestrians and cyclists to riverfront trails and parks on both sides of the bridge
