# **ROUTE 73 (SKIPPACK PIKE) BRIDGE IMPROVEMENT PROJECT**

Skippack Township  
Montgomery County

**June 2024**

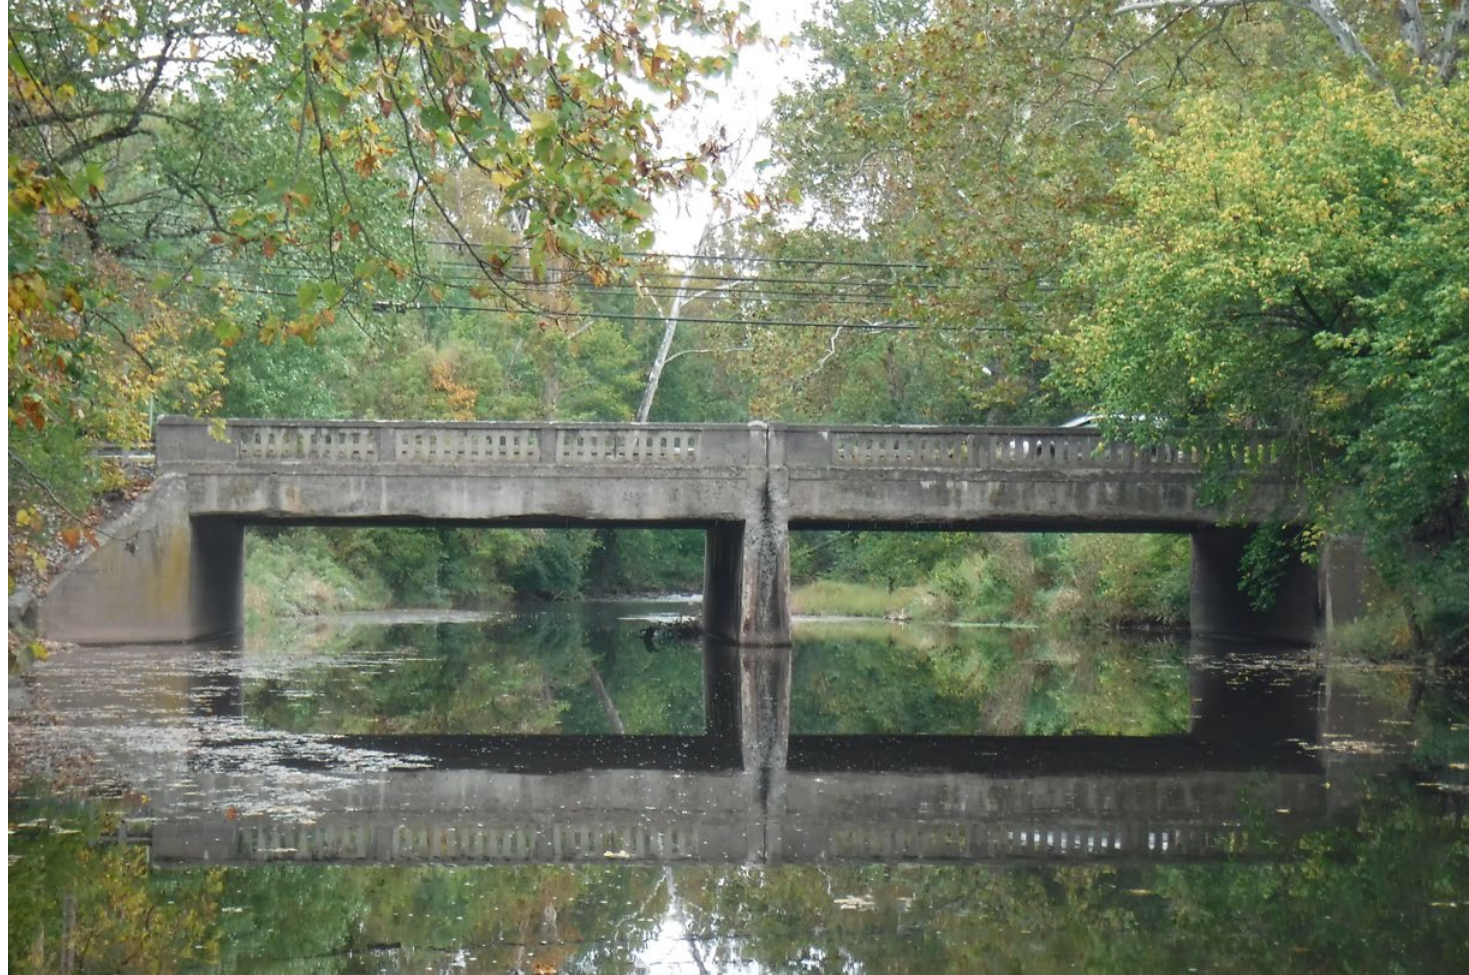
# EXISTING BRIDGE AND ROADWAY FEATURES

## Existing Structure

- 80 feet long, 2 spans, 44 feet wide curb to curb
- Reinforced concrete T-Beam bridge with concrete piers and abutments constructed in 1935
- Poor overall condition

## Existing Roadway

- 1 lane of traffic in each direction with shoulders varying from 3 - 8 feet
- Slight vertical curve impacting sight distance

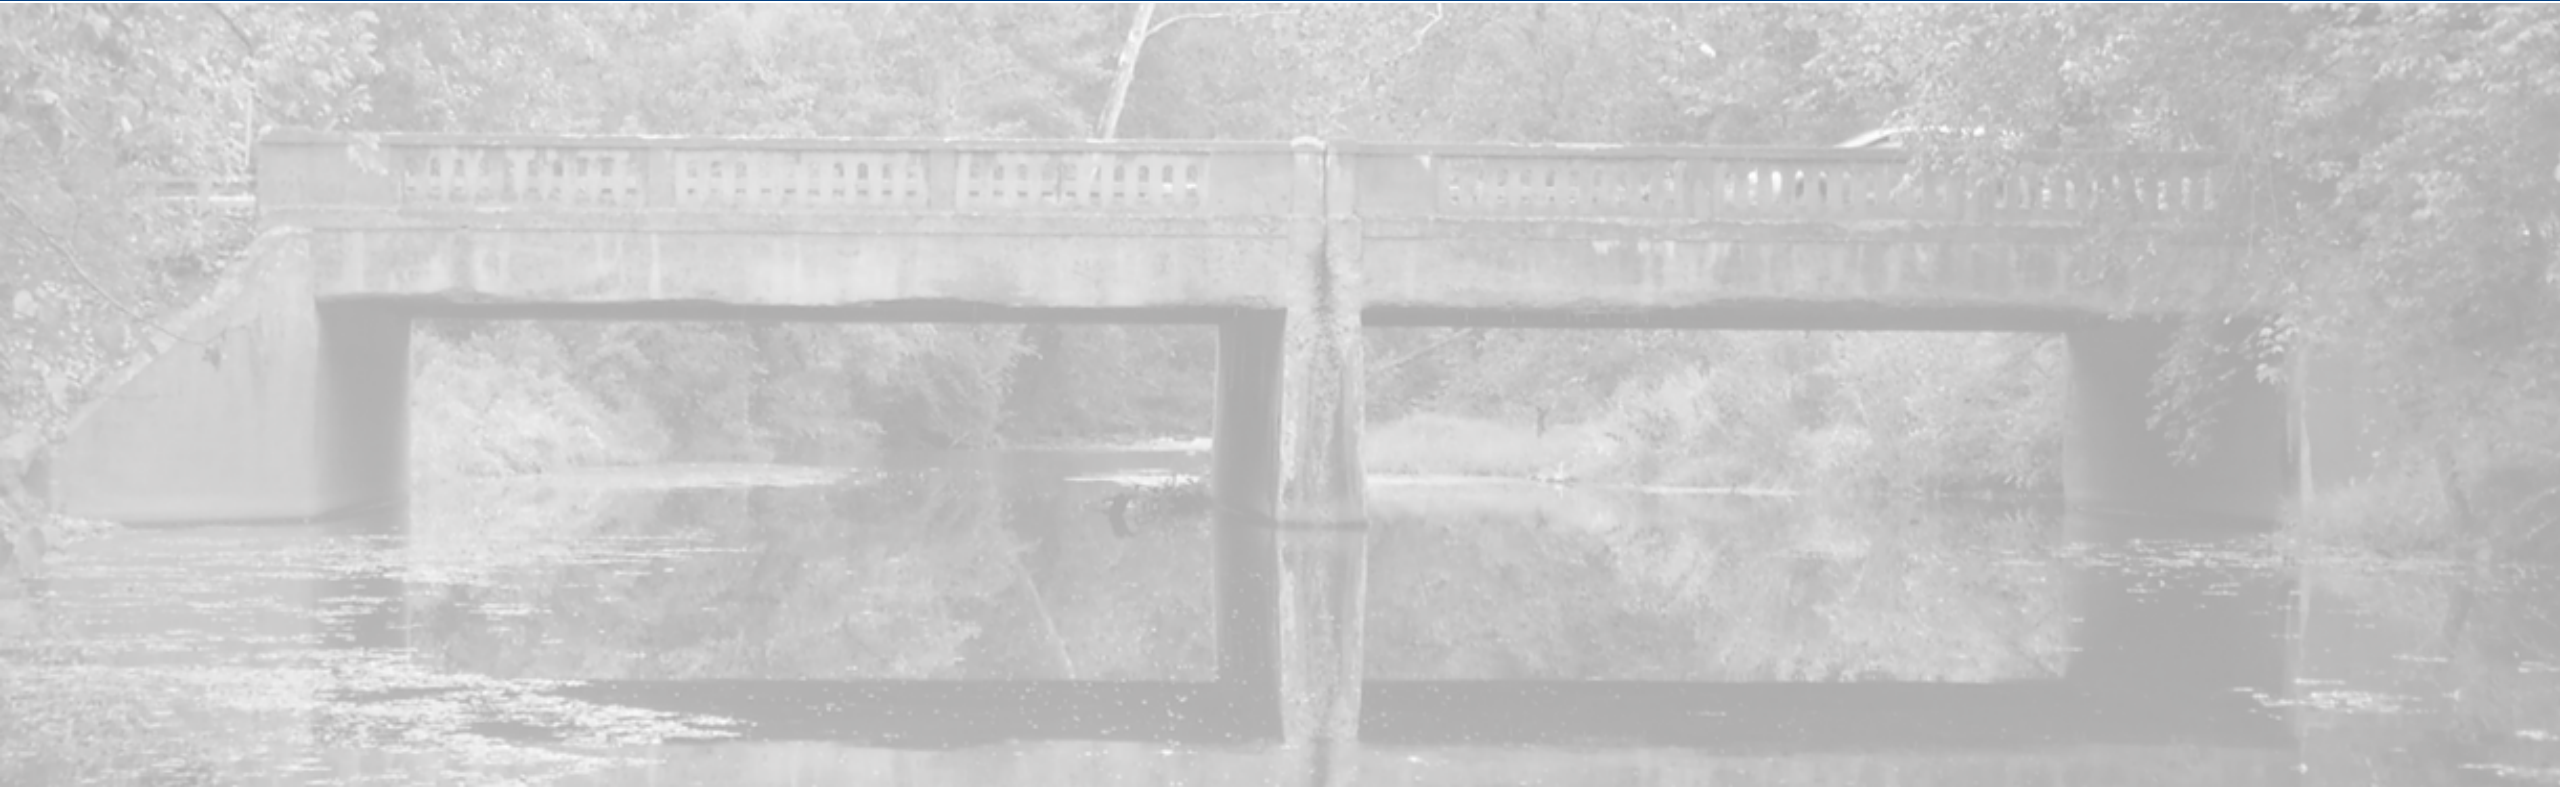
1. The Skippack Pike bridge is currently in poor condition.

2. Streambed scour has exposed the bridge footing.

3. Roadway embankment erosion on the upstream side of the bridge.

4. Western approach of Route 73 has sub-standard vertical sight distance.

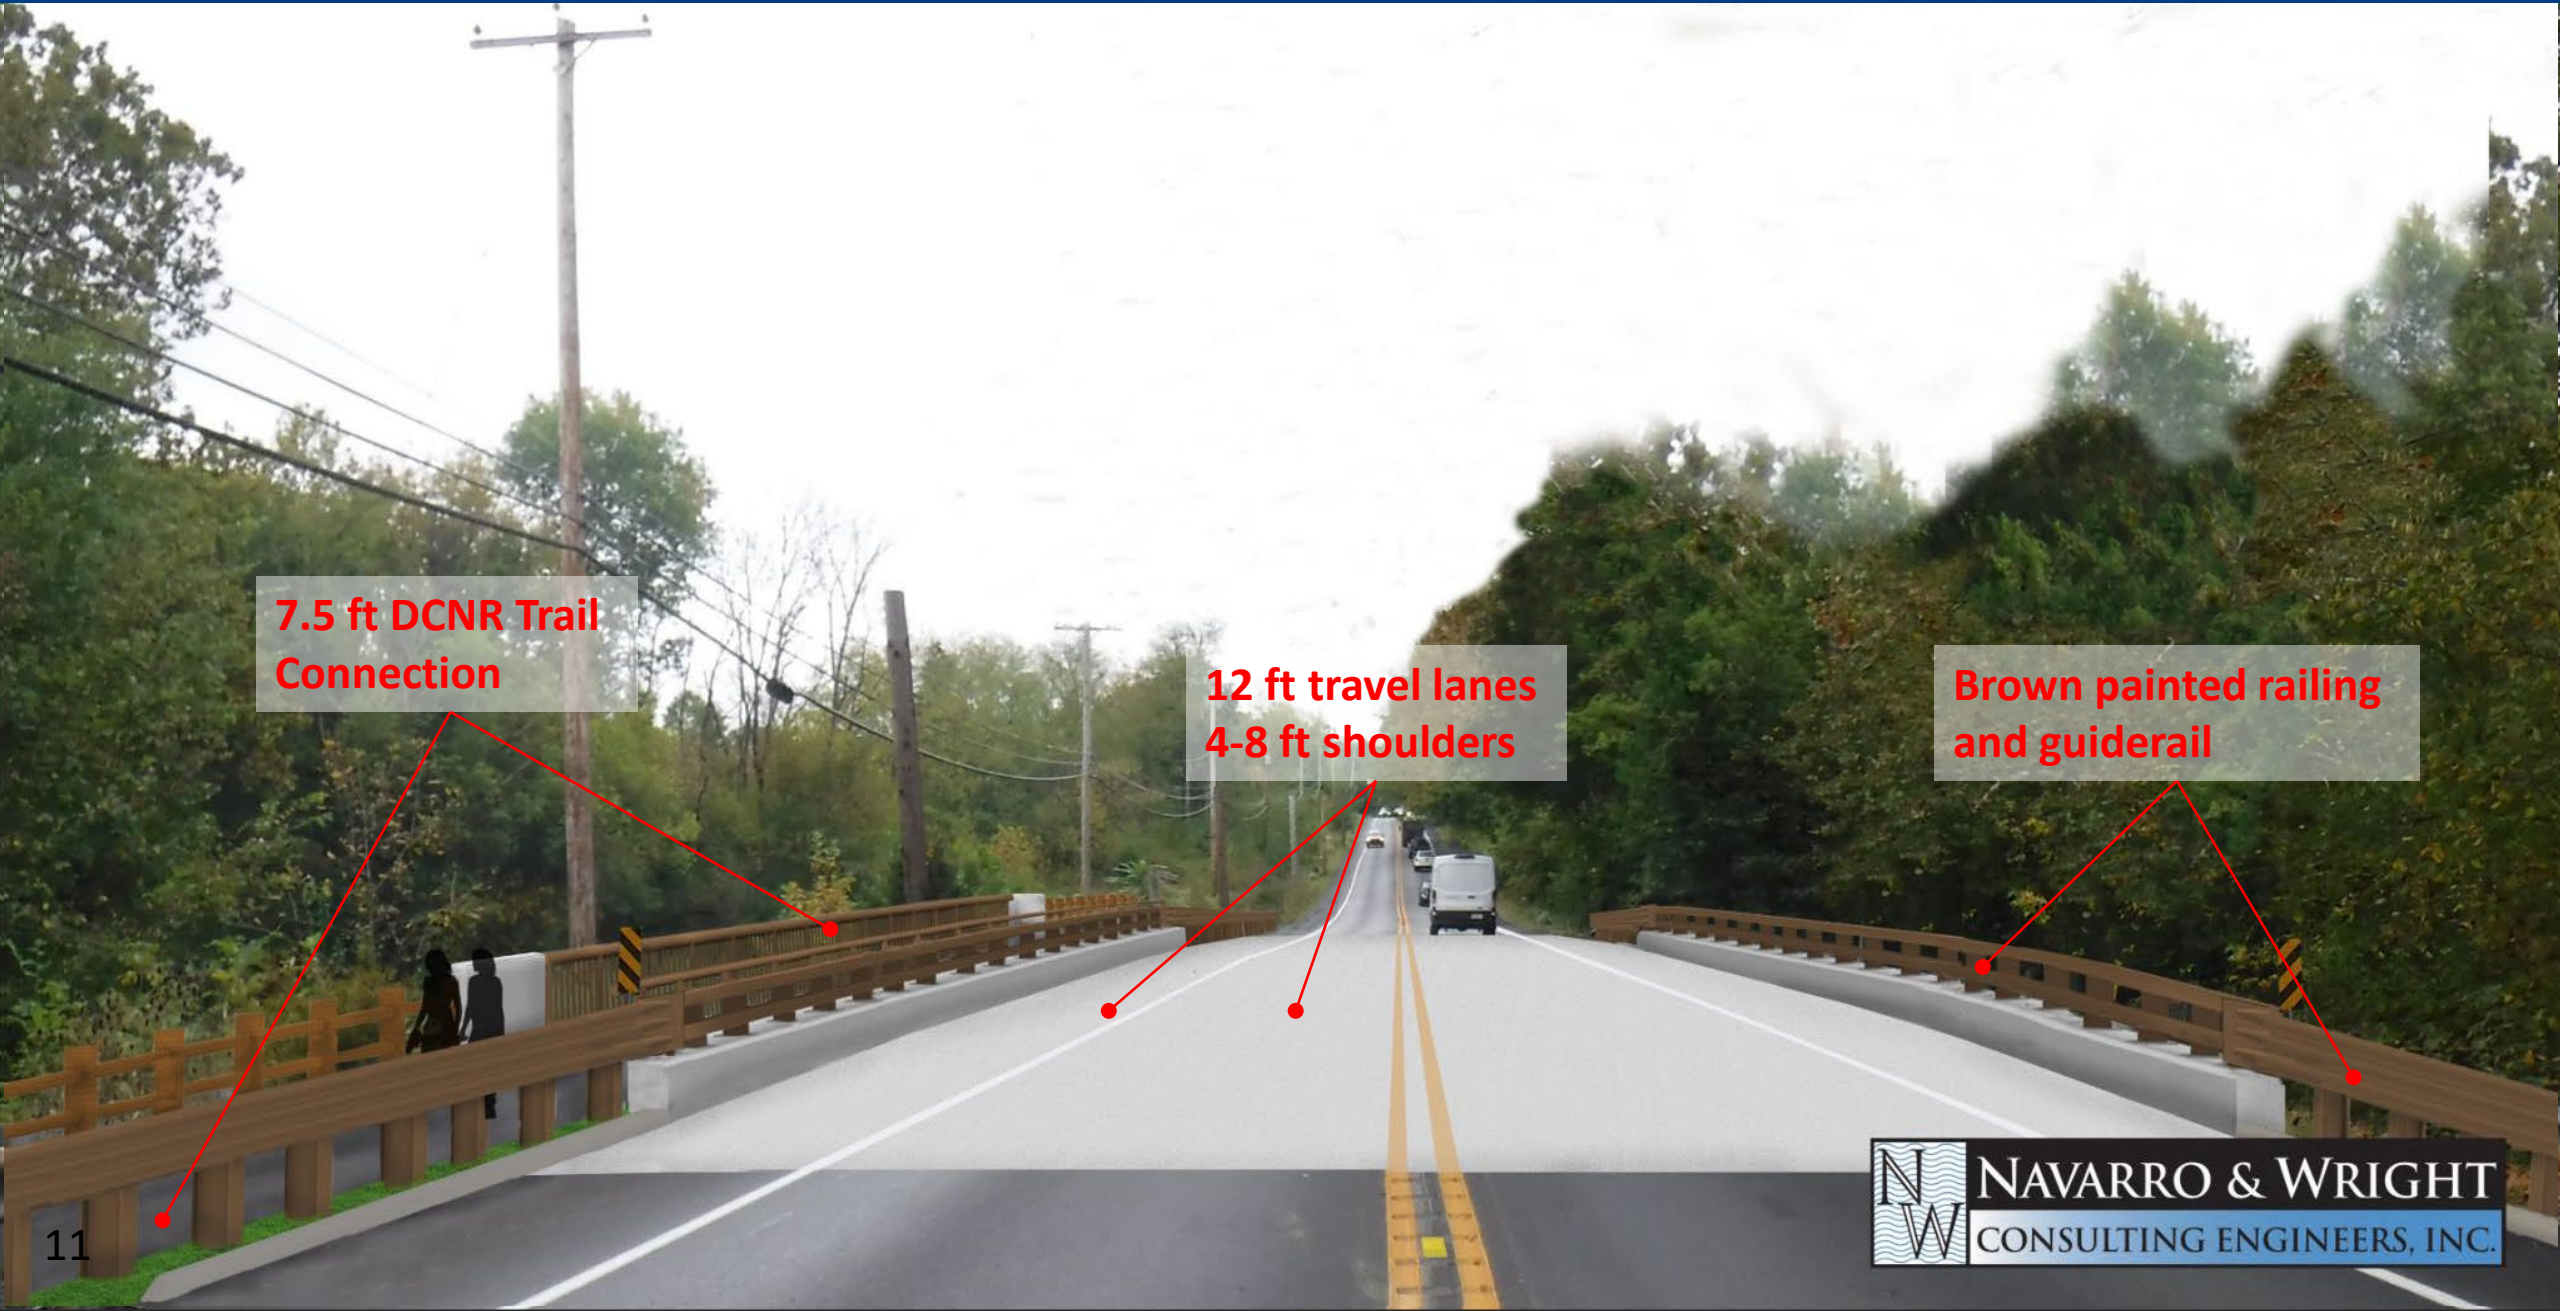
# PROJECT IMPROVEMENTS

7.5 ft DCNR Trail Connection

12 ft travel lanes  
4-8 ft shoulders

Brown painted railing and guiderail

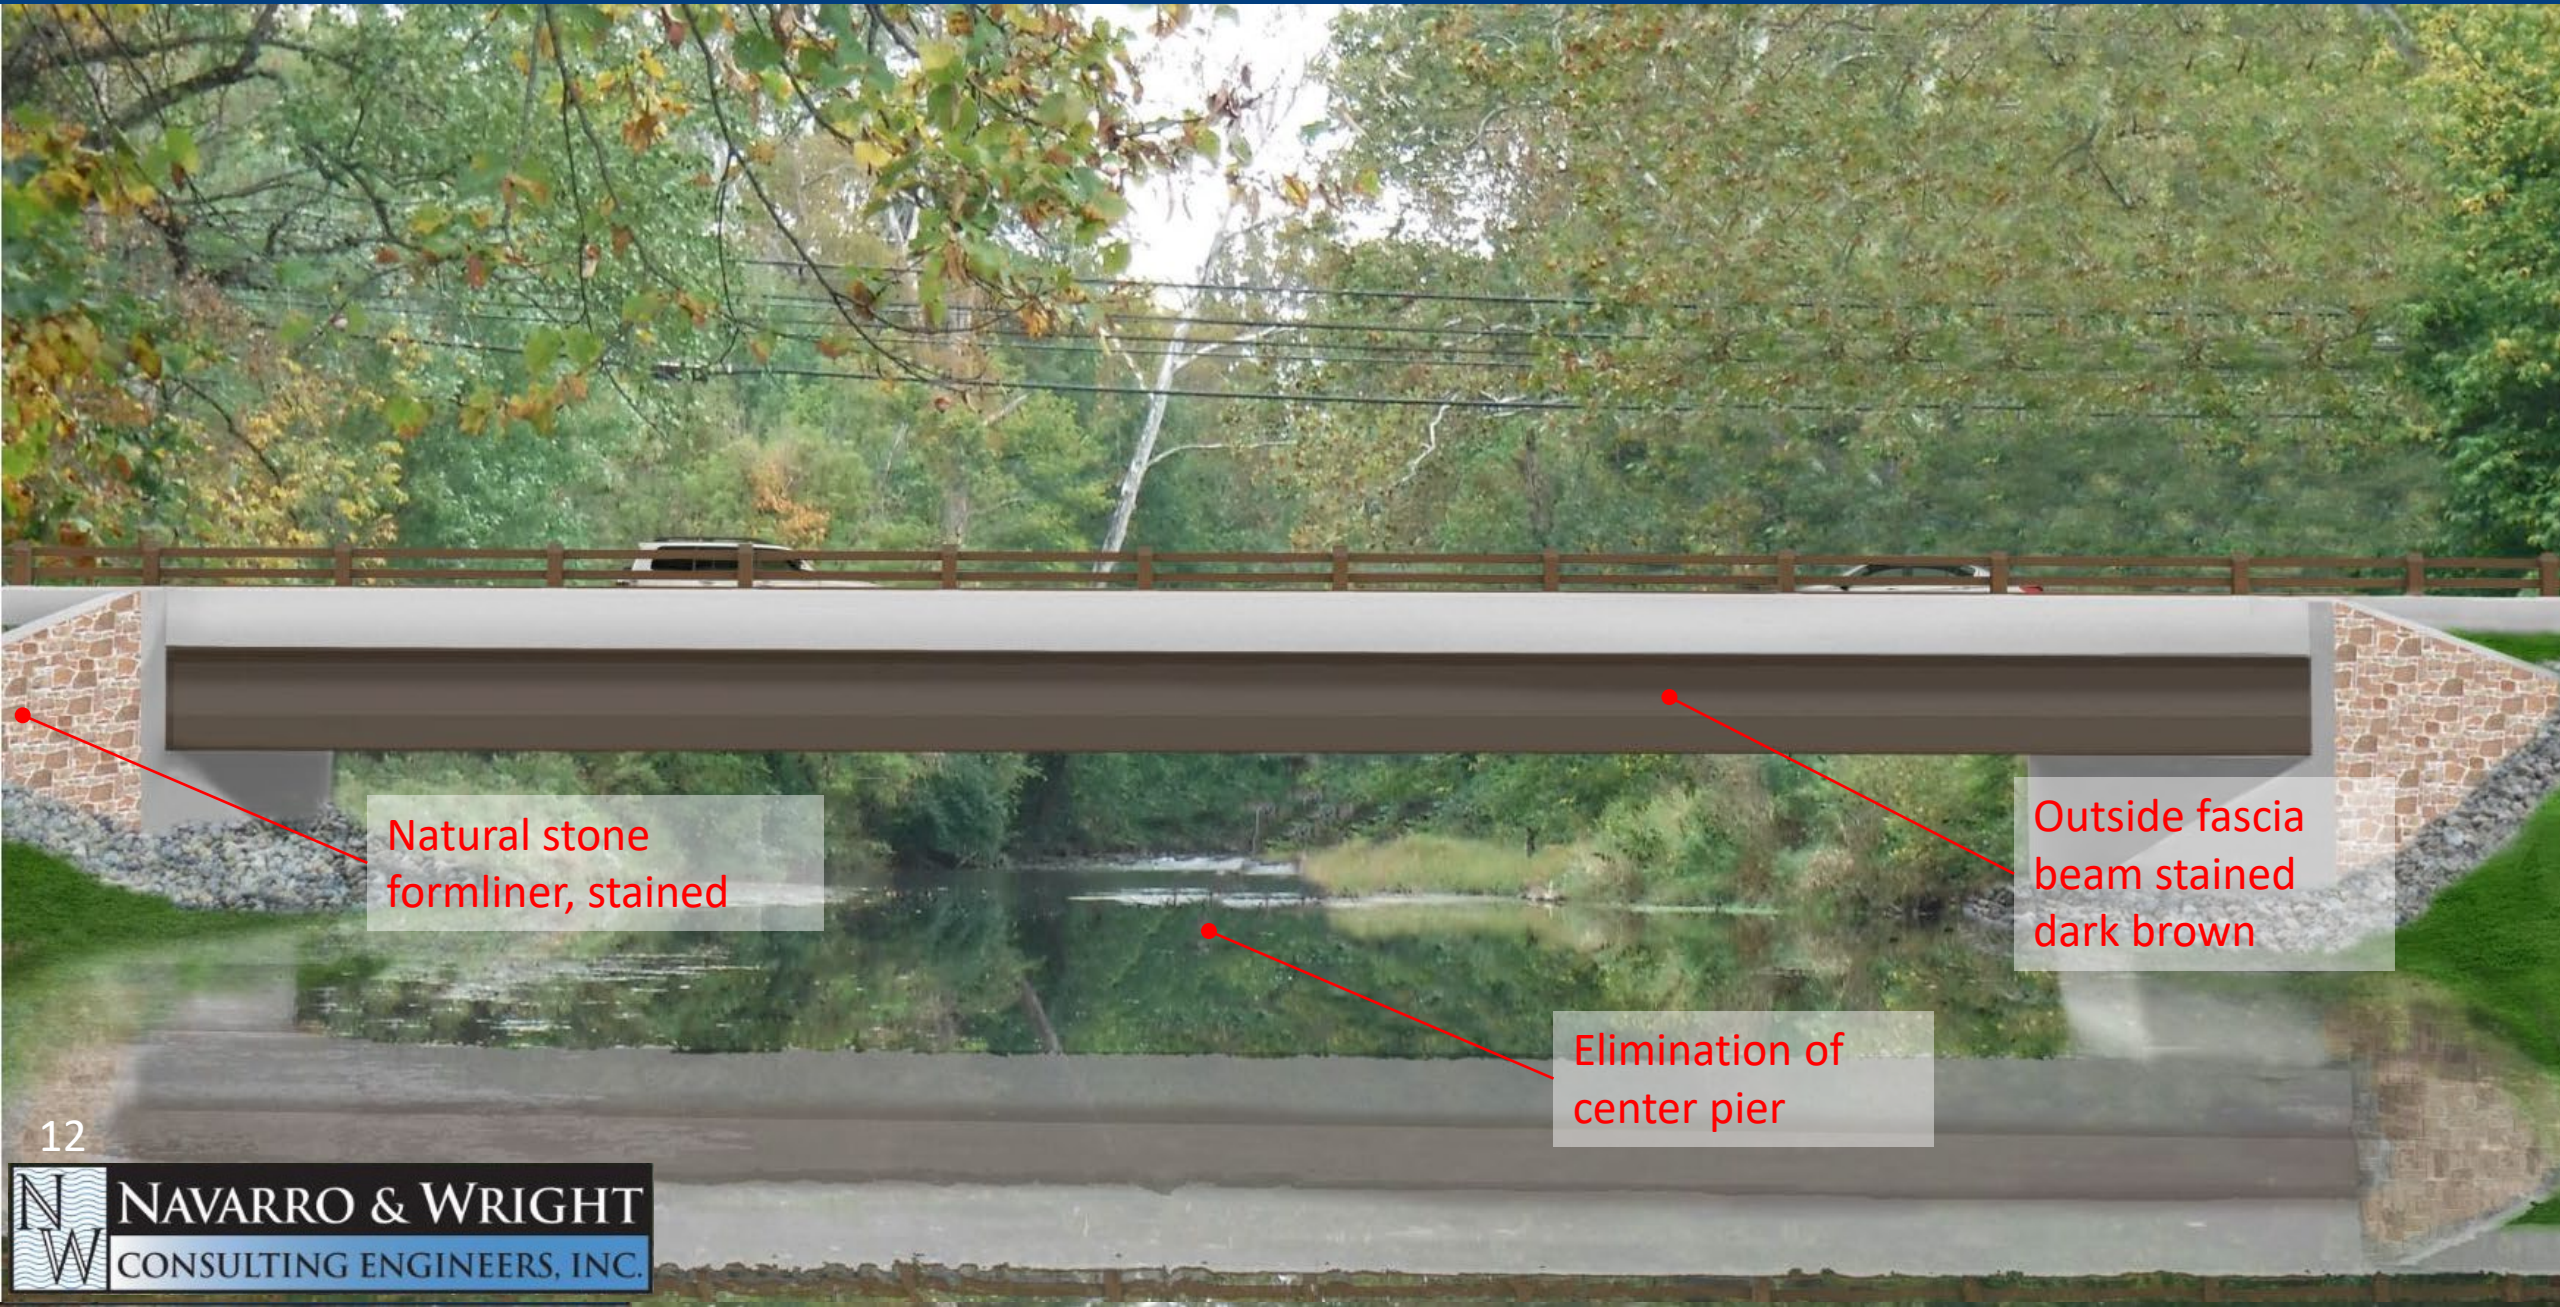
# PROJECT IMPROVEMENTS

Natural stone  
formliner, stained

Outside fascia  
beam stained  
dark brown

Elimination of  
center pier

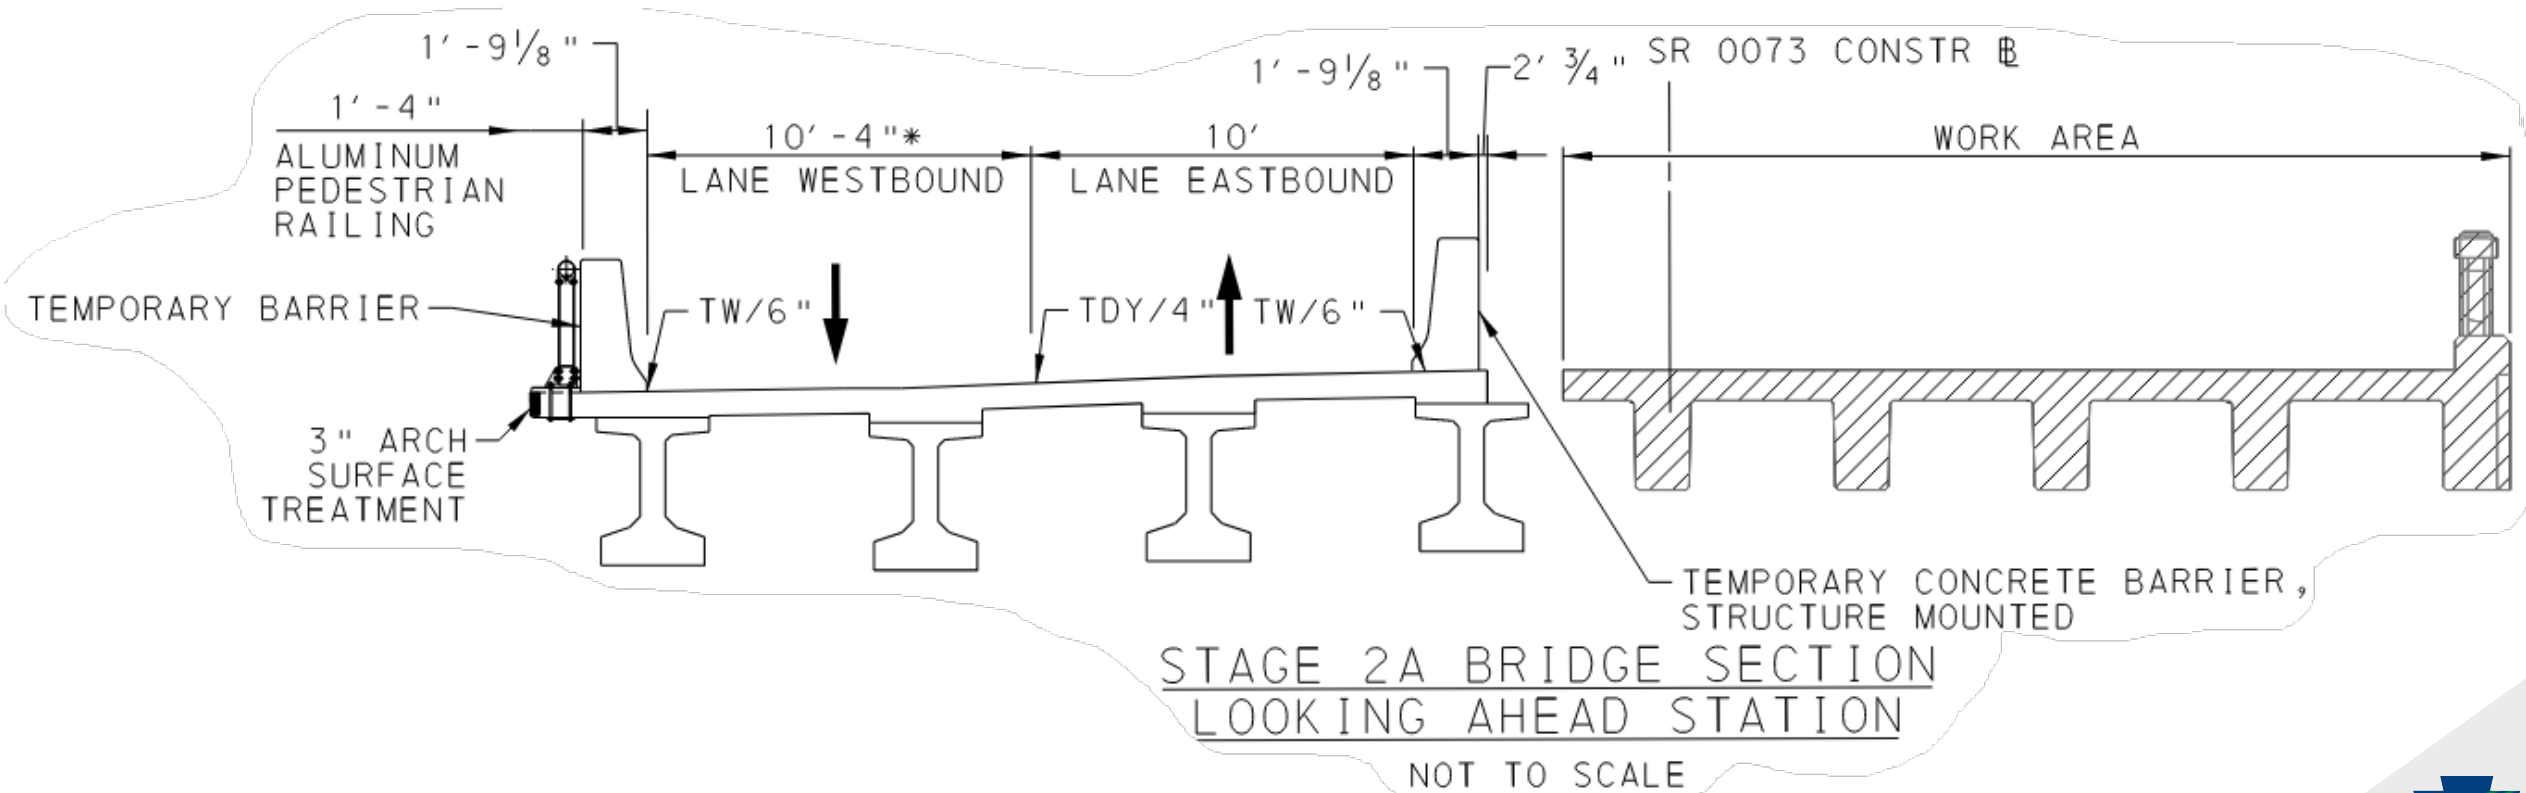
# DURING CONSTRUCTION TRAFFIC CONTROL

- Staged construction utilized to maintain the flow of traffic
- 1 lane of traffic will be maintained in each direction for the duration of construction
